INDOOR AIR QUALITY ASSESSMENT

**Burgess Elementary School
45 Burgess School Road
Sturbridge, Massachusetts**

Prepared by:
Massachusetts Department of Public Health
Center for Environmental Health
Bureau of Environmental Health Assessment
Emergency Response/Indoor Air Quality Program
September 2004

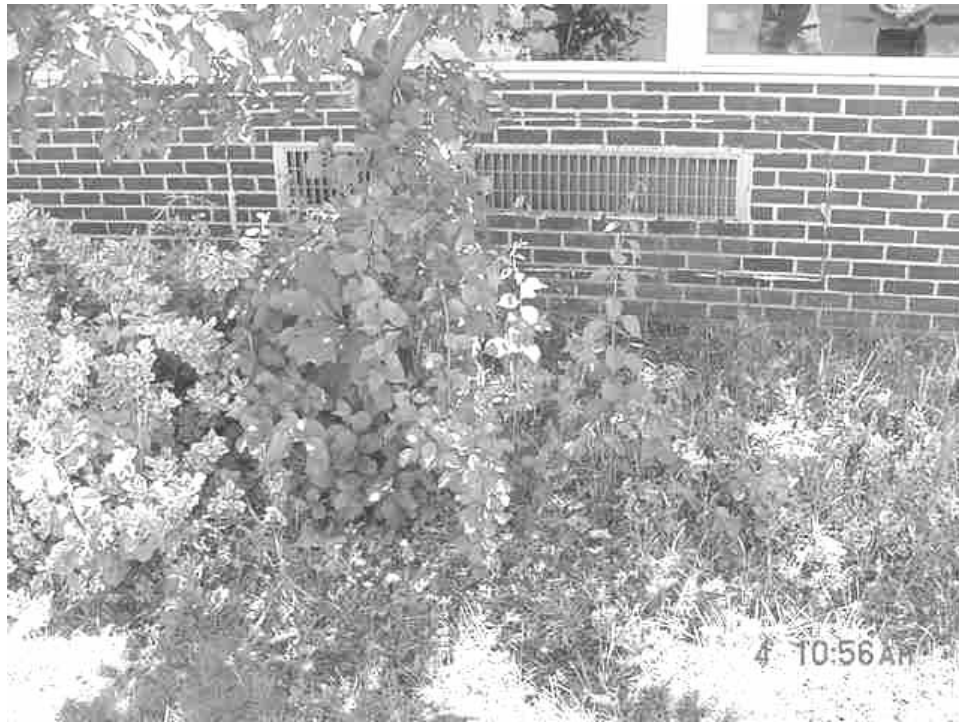
Picture 1

Fresh air in classrooms in the 1948 wing is mechanically supplied by a unit ventilator (univent) system. Univents draw air from outdoors through a fresh air intake located on the exterior walls of the building (Picture 1) and return air through an air intake located at the base of each unit. Fresh and return air are mixed, filtered, heated and provided to classrooms through an air diffuser located in the top of the unit ([Figure 1](#)). Univents were found deactivated in a number of classrooms. Obstructions to airflow, such as items on top of univents and/or tables and desks in front of univent returns, were also seen in a number of classrooms (Picture 2). To function as designed, univents must be activated and remain free of obstructions.

Plants were located in front of univent air intakes and/or near univents air diffusers (Pictures 1 and 9). Plants, soil and drip pans can serve as sources of mold growth. Over-watering of plants should be avoided and drip pans should be inspected periodically for mold growth. Plants should also be located away from univents and ventilation sources to prevent aerosolization of dirt, pollen or mold.

Univent Fresh Air Intake, Note Plant Growth in Front of Vent

10. Remove foliage to a minimum of five feet away from the foundation. Trim trees in rear of building that overhang the roof. Ensure univent air intakes on the exterior of the building are free of obstruction.

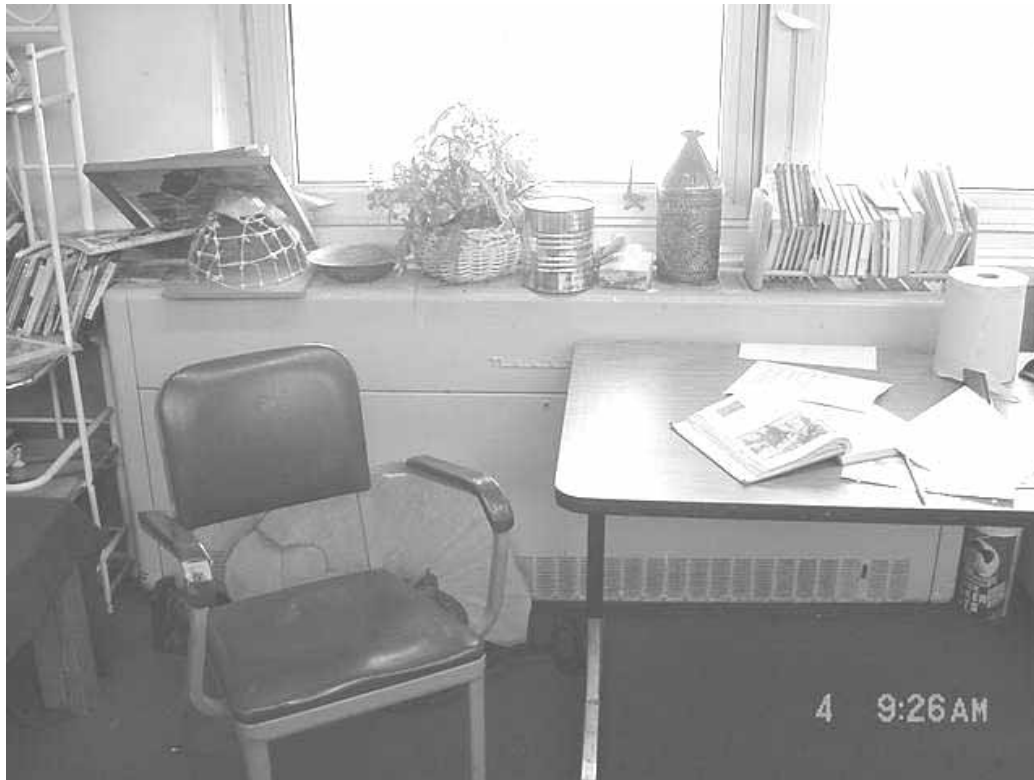
Picture 2

Classroom Univent Obstructed by Various Items, Univert is Late 1940s model

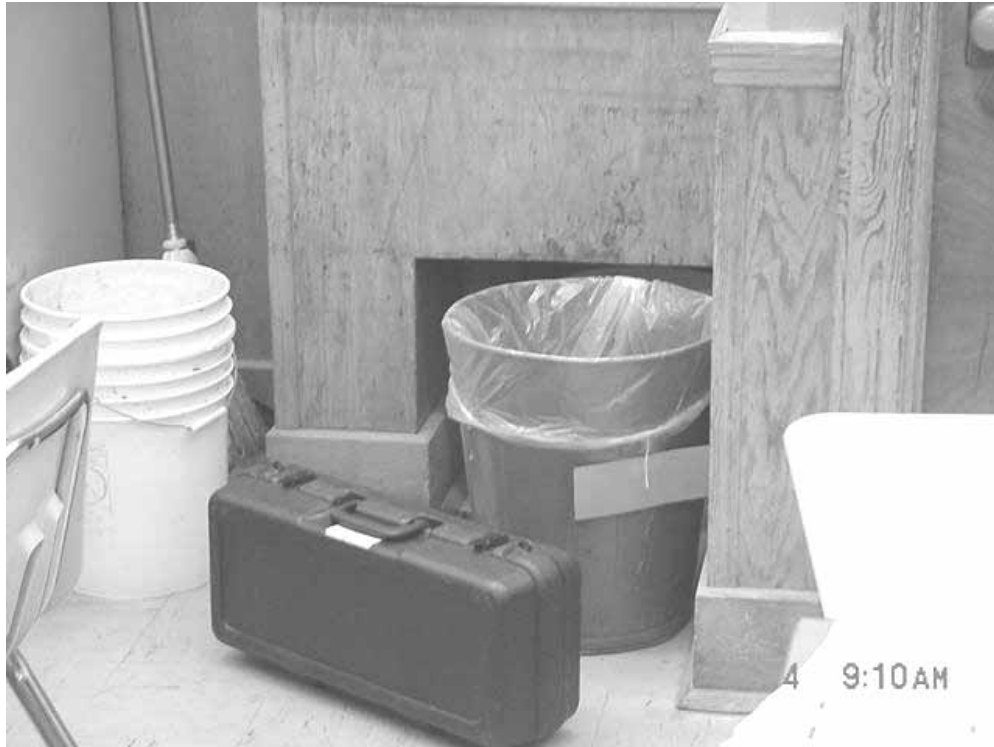
Picture 3

Exhaust ventilation in the 1948 wing is provided by gravity vents, which consist of ungrated floor level “cubby” holes. As outside air is introduced into classrooms via the univents or open windows, the room becomes pressurized forcing air into the cubbies and out the exhaust vents. These vents were being used for storage throughout the wing, thereby obstructing airflow (Picture 3). Without sufficient supply and exhaust ventilation, environmental pollutants can build up and lead to indoor air quality complaints.

Items Stored in Exhaust Vent “Cubby”, 1954 Wing

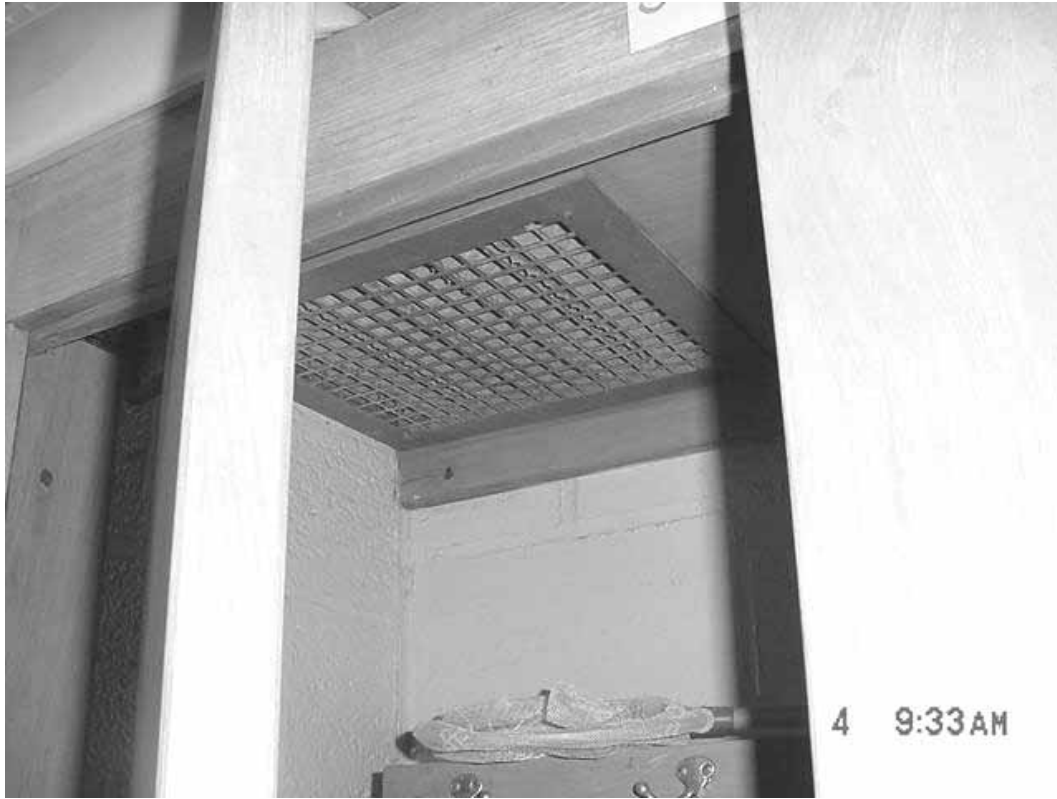
Picture 4

Mechanical exhaust ventilation in the 1954 wing classrooms consists of grilles located in the ceilings of coat closets (Picture 4), which are powered by rooftop motors. Air is drawn into

Exhaust Vents in Ceilings of Coat Closets, 1960 Wing

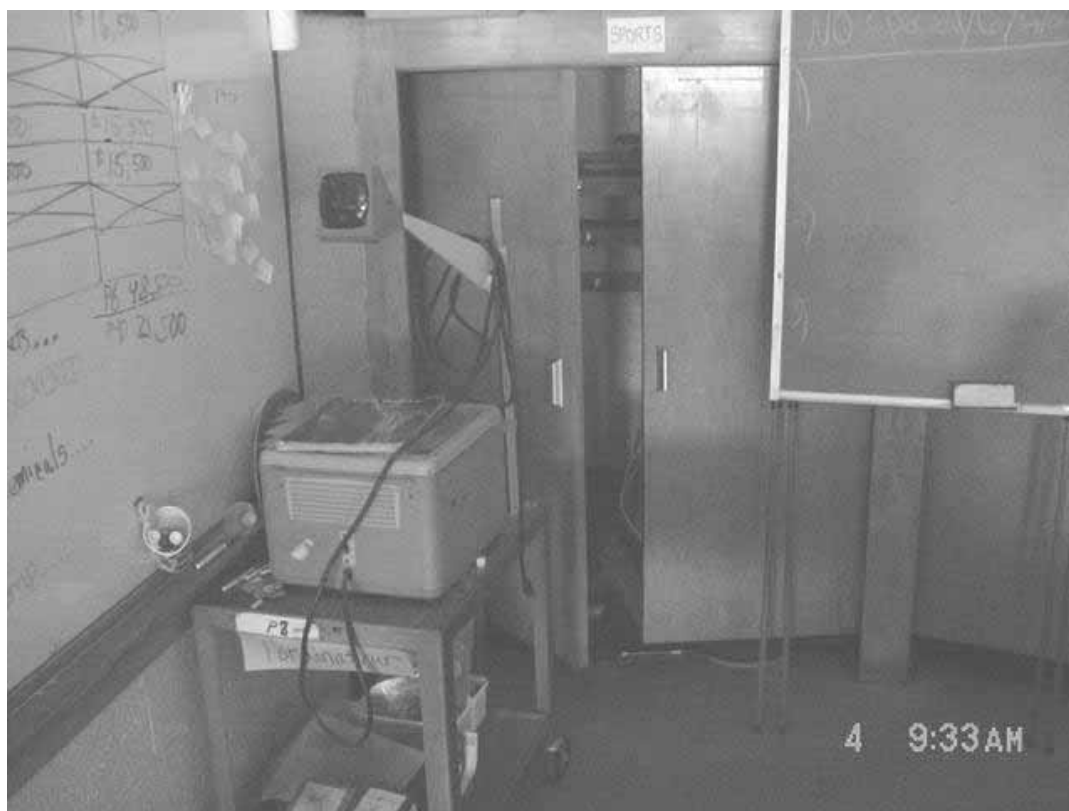
Picture 5

the coat closet from the classroom via undercut closet doors (Picture 5). This exhaust system was either not functioning or drawing weakly in several areas surveyed, indicating the motors were deactivated or non-functional. BEHA staff examined exhaust motors on the roof and found several not operating. Mr. Coon reported that several of the exhaust motors were on a work list and scheduled for repair. In addition, the location of these closet vents allows them to be easily blocked by stored materials. As with the univents, in order to function properly, exhaust vents must be activated and remain free of obstructions.

Full-View of Coat Closet, 1960 Wing

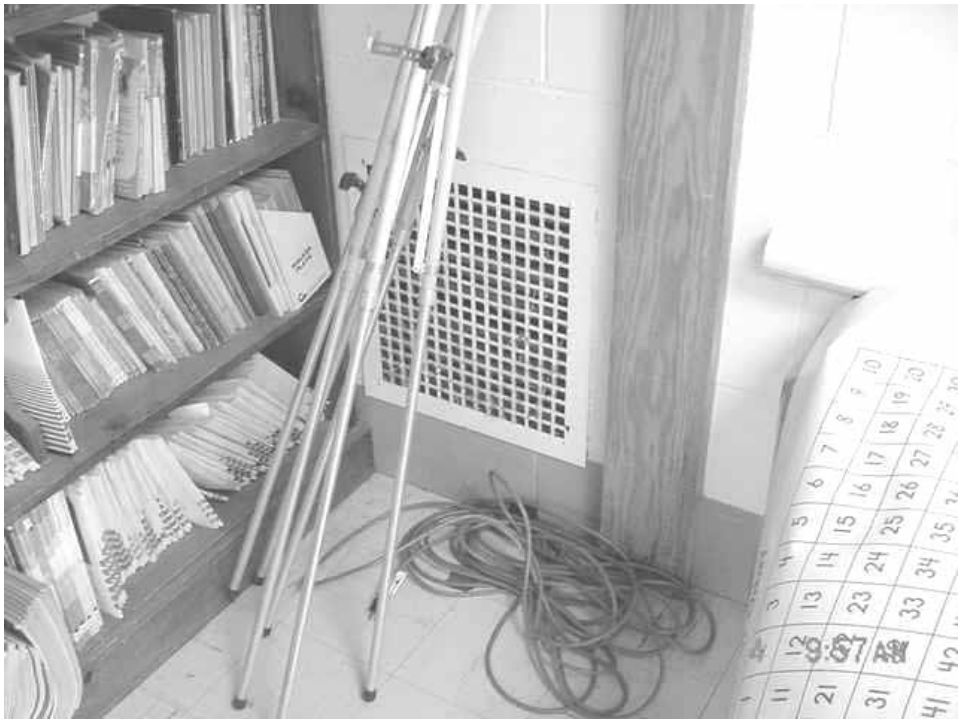
Picture 6

Mechanical exhaust ventilation in the 1960 wing is also provided by univents. Many units were deactivated or obstructed at the time of the assessment. Exhaust ventilation is provided by grated wall vents (Picture 6), which are powered by rooftop motors. As with other wings, a number of vents were not drawing air or drawing weakly. Some exhaust vents were also obstructed.

Exhaust Vent 1960 Wing

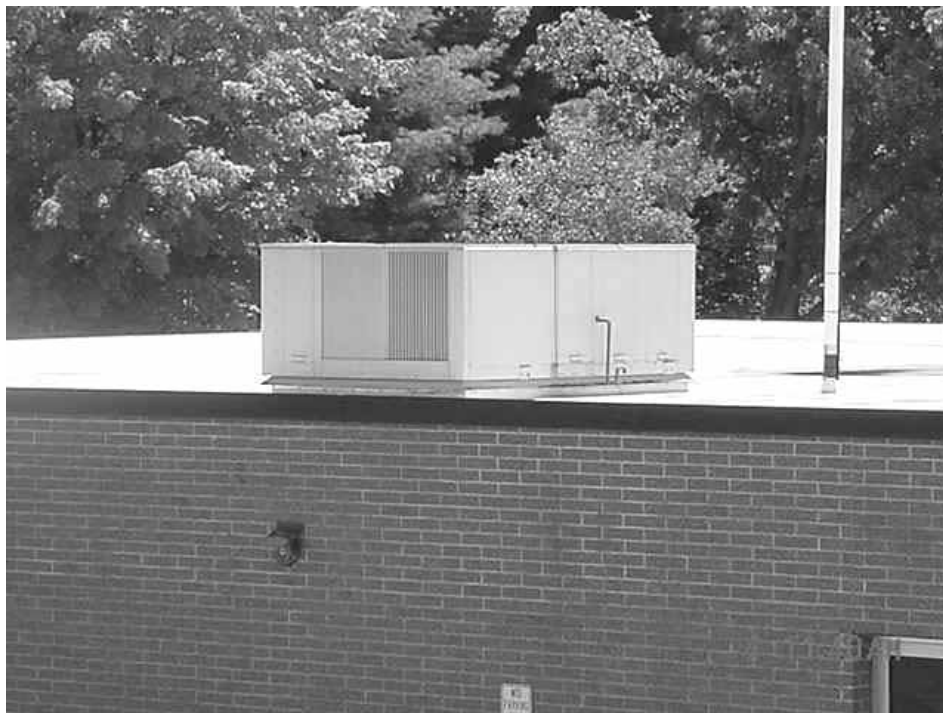
Picture 7

Mechanical ventilation in this wing is provided by rooftop air handling units (AHUs) ducted to ceiling-mounted air diffusers (Picture 7). Return air is ducted back to the AHUs via ceiling or wall mounted return vents. At the time of the assessment, Mr. Coon reported that the AHU for the computer lab and kindergarten classrooms had ceased operating, and a request for proposal (RFP) to replace the AHU had gone out to bid. As a temporary measure, exterior doors had been opened to provide fresh air in these areas.

Rooftop AHU, 1973 Wing

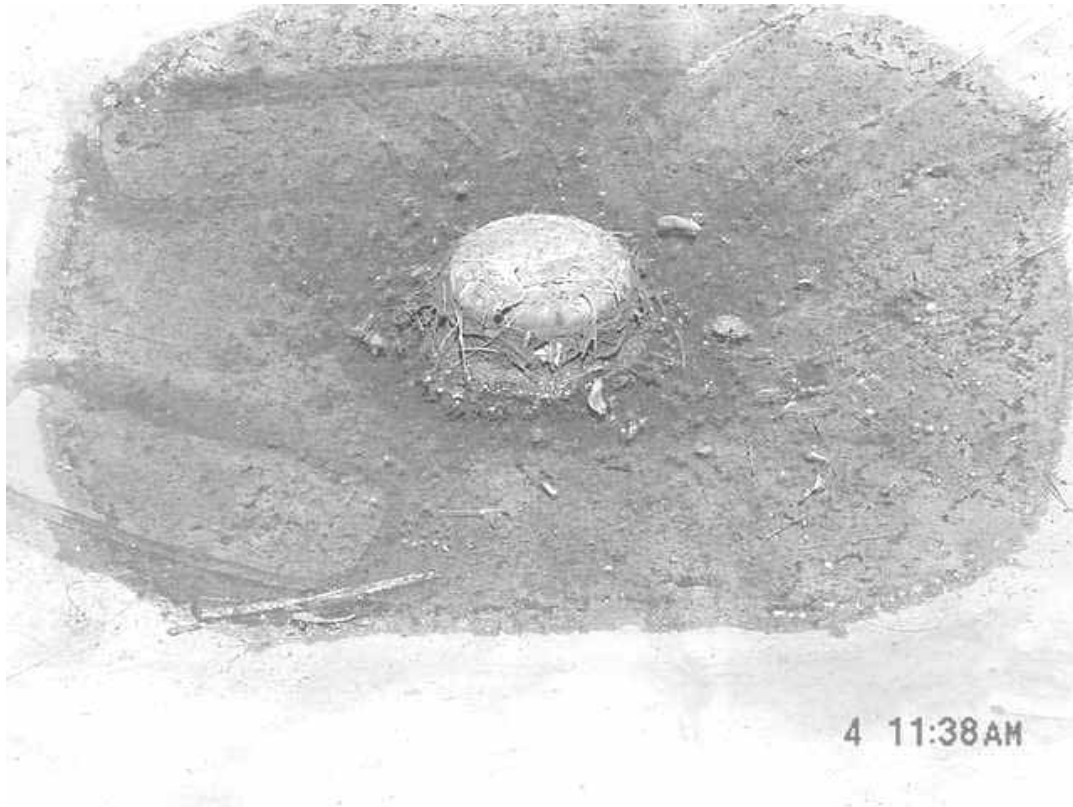
Picture 8

Pooling water was observed around clogged roof drains (Picture 8). The freezing and thawing of water during winter months can lead to roof leaks and subsequent water penetration into the interior of the building. Pooling water can also become stagnant, which can lead to mold and bacterial growth. Such growth and associated odors can also be introduced to the building by rooftop ventilation equipment. In addition, stagnant pools of water can serve as a breeding ground for mosquitoes.

Clogged Roof Drain

8. Remove accumulated plant debris from roof. Inspect roof drains regularly for proper drainage.
9. Ensure plants have drip pans. Examine drip pans periodically for mold growth and disinfect with an appropriate antimicrobial where necessary. Keep plants away from the air stream of univents.

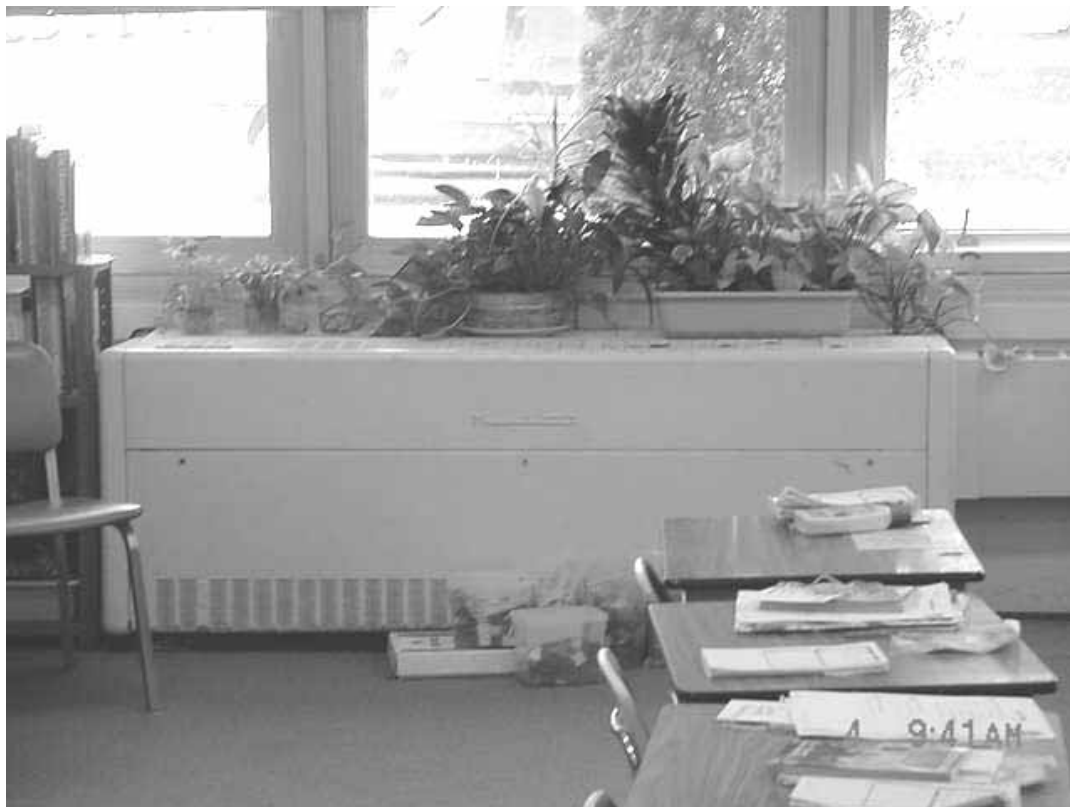
Picture 9

Plants on Univent Air Diffuser

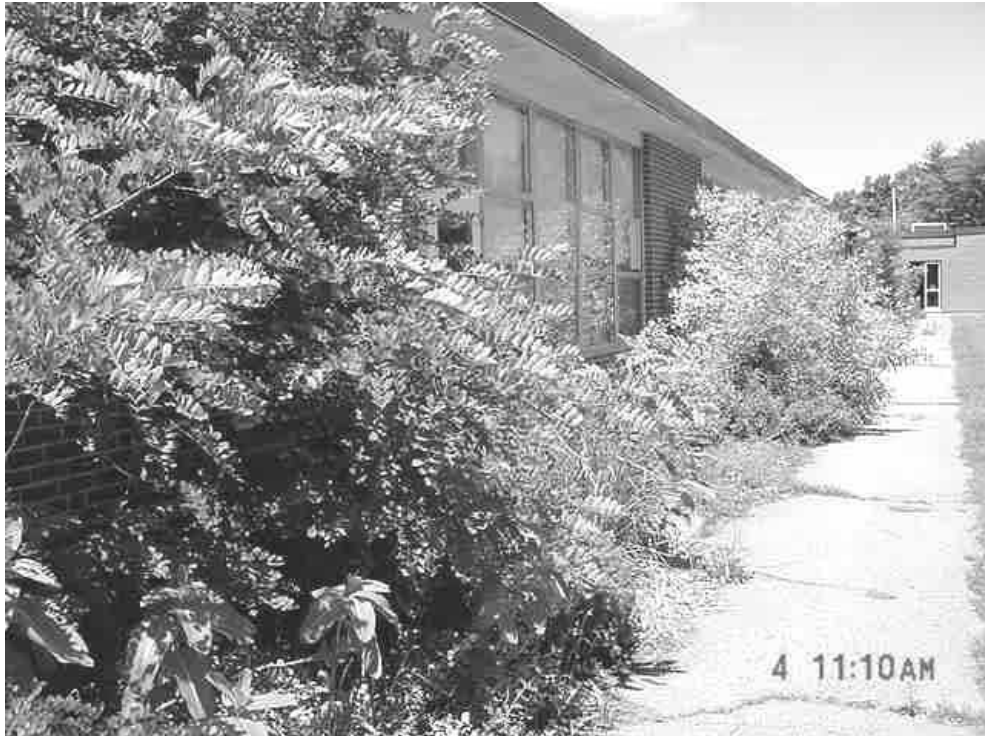
Picture 10

Shrubby and other plants were also seen growing in close proximity to exterior walls (Pictures 10 and 11). The growth of roots against the exterior walls can bring moisture in contact with wall brick. Plant roots can eventually penetrate the brick, leading to cracks and/or

fissures in the below ground level foundation. Over time, this process can undermine the integrity of the building envelope, providing a means of water entry into the building through capillary action through foundation concrete and masonry (Lstiburek & Brennan, 2001).

Plant/Tree Growth Against Exterior Brickwork

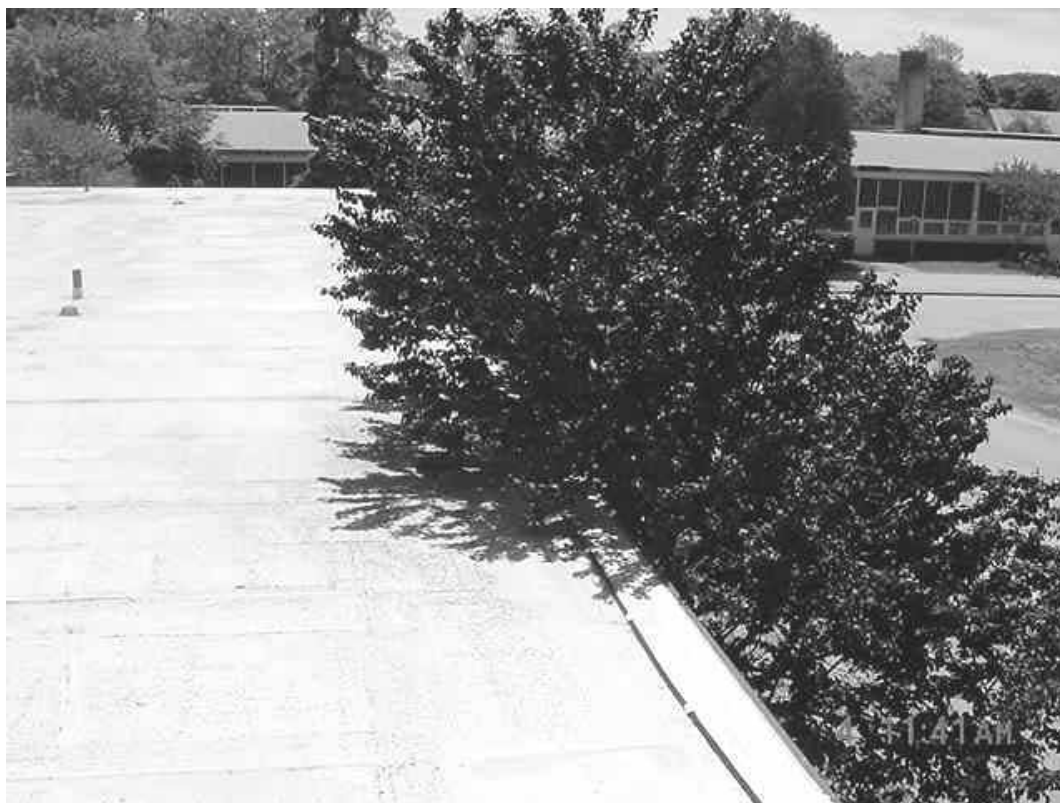
Picture 11

Tree Growth Against/Over Roof of School

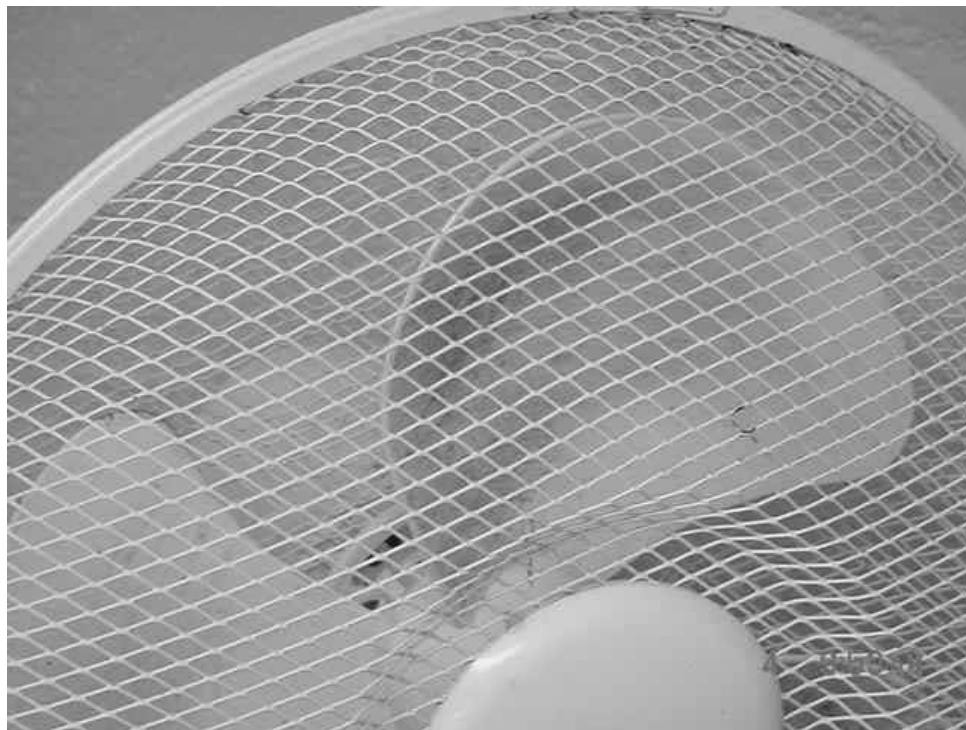
Picture 12

Accumulated Dust on Fan Blades

14. Clean accumulated dust from exhaust vents and blades of personal fans.
15. Clean chalkboard/dry erase marker trays regularly to prevent the build-up of excessive chalk dust and particulate.

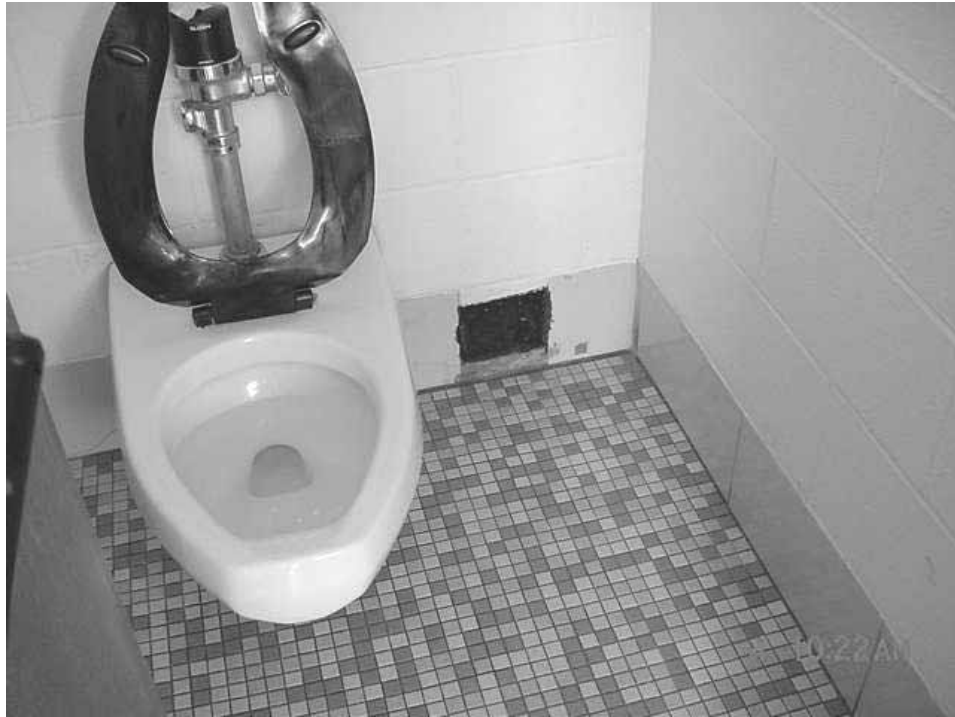
Picture 13

Occupants reported musty odors in the restrooms near classroom 21. These odors were also detected by BEHA staff. Exhaust vents in these restrooms were not drawing air. In addition, the exhaust vent in one restroom had a grill missing (Picture 13); the vent in the other restroom was sealed. Exhaust ventilation in restrooms is important in removing excess moisture and odors. Although no complaints were reported, the potential of odor entrainment into the

Missing Exhaust Vent Grill in Restroom, Near Classroom 21

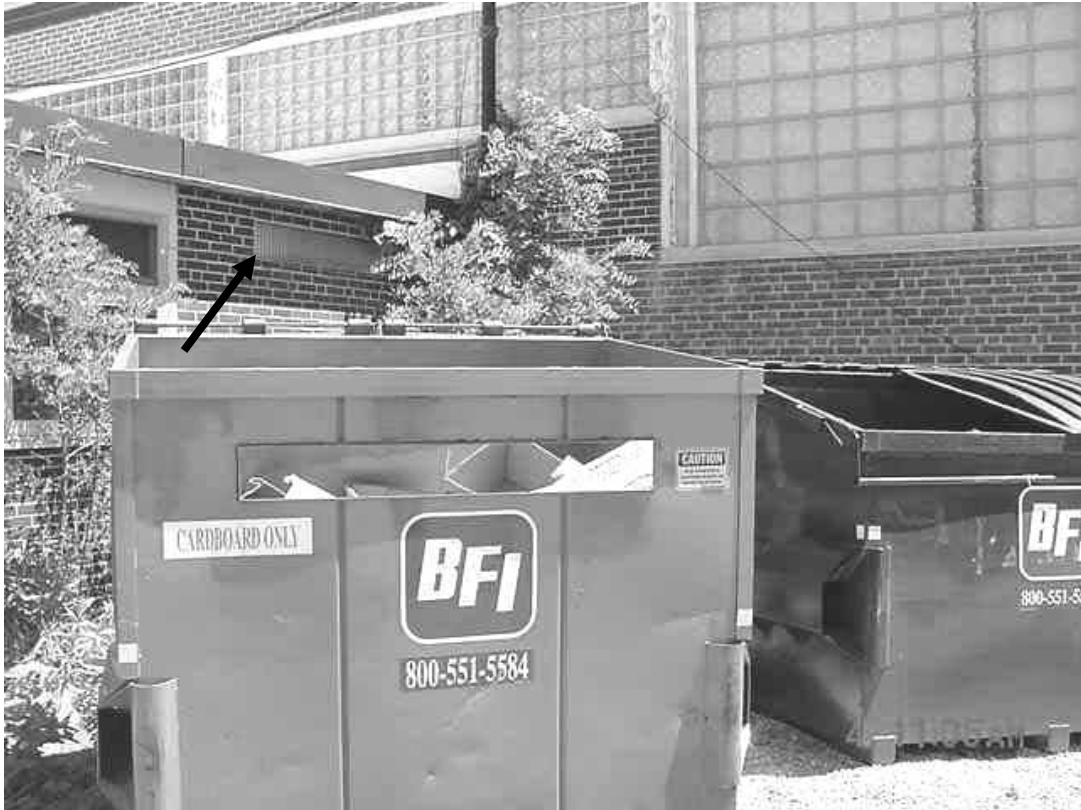
Picture 14

school exists. Several dumpsters behind the building were observed in close proximity to univent air intakes (Picture 14).

Dumpsters in Close Proximity to Air Intakes

16. Consider relocating dumpsters away from air intakes to prevent the entrainment of odors.
17. Store nests in resealable bags to prevent aerosolization of irritants.

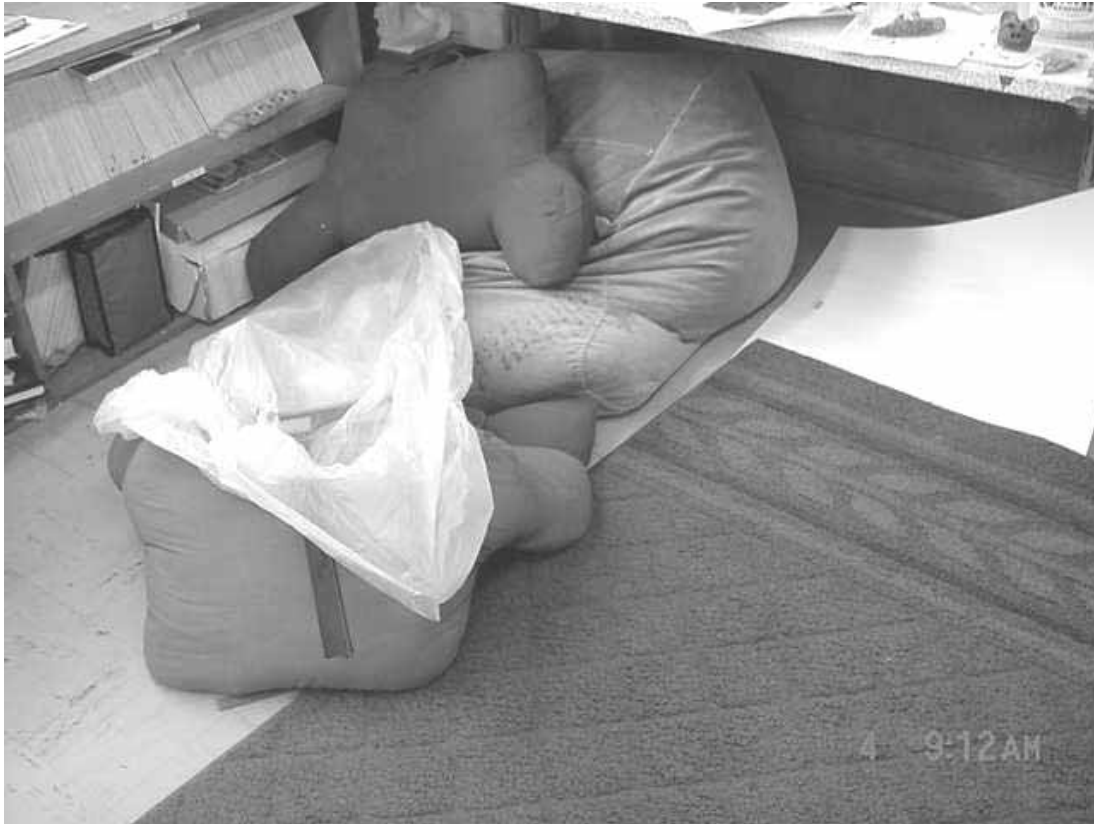
Picture 15

Several classrooms contained upholstered furniture, large cushions and/or pillows (Picture 15). Upholstered furniture is covered with fabric that comes in contact with human skin. This type of contact can leave oils, perspiration, hair and skin cells. Dust mites feed upon human skin cells and excrete waste products that contain allergens. In addition, if relative humidity levels increase above 60 percent, dust mites tend to proliferate (US EPA, 1992). In order to remove dust mites and other pollutants, frequent vacuuming of upholstered furniture is recommended (Berry 1994). It is also recommended that upholstered furniture present in schools be professionally cleaned on an annual basis. If an excessively dusty environment exists due outdoor conditions or indoor activities (e.g., renovations), cleaning frequency should be increased to every six months (IICR, 2000). Elevated outdoor levels of airborne particulates can result in increased levels of indoor particulates by entering into the building through open windows, doors and filter bypass.

Cushions and Pillows on Floor of Classroom

18. Clean upholstered furniture on the schedule recommended in this report. If not possible/practical, remove upholstered furniture from classrooms.
19. Consider adopting, the US EPA (2000b) document, Tools for Schools, in order to provide self assessment and maintain a good indoor air quality environment at your building. The document can be downloaded from the Internet at <http://www.epa.gov/iaq/schools/index.html>.
